# OPERATIONS SAFETY NOTICE

## OSN 47-09-9

SUBJECT: **MAIN ROTOR HUB INBOARD THRUST DUPLEX BEARING  
047-120-417-XXX, IDENTIFICATION OF THRUST SIDE.**

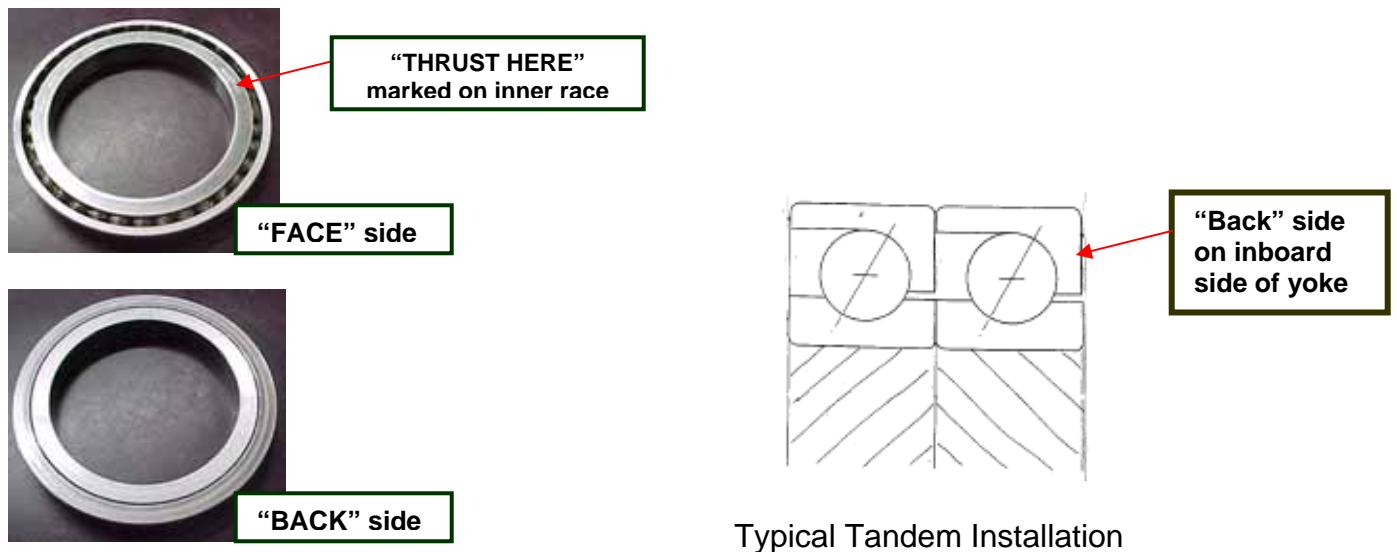
Bell helicopter has received an unconfirmed report of main rotor hub inboard thrust duplex bearing premature degradation due to improper installation. At this stage of the investigation, it is suspected that the "THRUST HERE" marking on the "Face" side of the bearing may cause confusion and lead to improper installation of the bearing.

This Operation Safety Notice (OSN) is issued to advise Owners/Operators of this potential situation and clarify the correct installation of the main rotor hub inboard thrust duplex bearing. For correct installation, refer to the applicable Maintenance & Overhaul Manual and the pictures/figure below. This installation is commonly named "TANDEM DUPLEX".
