OPERATIONS SAFETY NOTICE

OSN 47-14-12

To: **All Owners and Operators of Bell Model 47 Helicopters**

Subject: **Proper Procedures to Ensure Safety of Throttle Linkage**

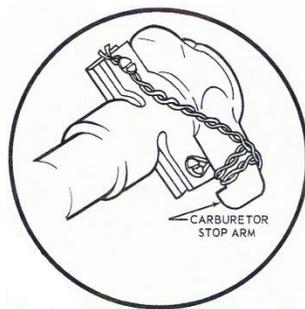
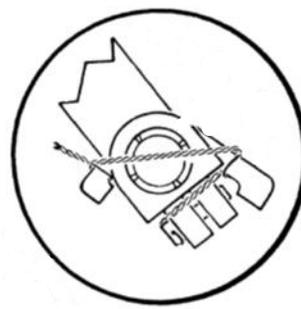
In a review of accident history, Scott's – Bell 47, Inc. has concluded that there is an unacceptable trend of engine power loss due to the separation of the throttle linkage from the throttle stop arm.

A sketch like one of the above can found in the Maintenance and Overhaul Instructions and depicts a typical correct installation of the safety wire.

Maintainers are reminded that properly installed safety wire secures the two throttle linkage clamp screws and also encompasses the throttle stop arm thereby adding redundant throttle control safety.

Pilots are reminded that in their normal pre-flight check to determine suitability for flight, the check to ensure flight control condition and security includes the throttle linkage connection to the carburetor throttle stop arm.
